Manhole Inspection Summary

Manhole # S11GG2011MH

Insp Date: **7/10/06 9:29 AM**

Location Address: **2313 ROGENE DR**

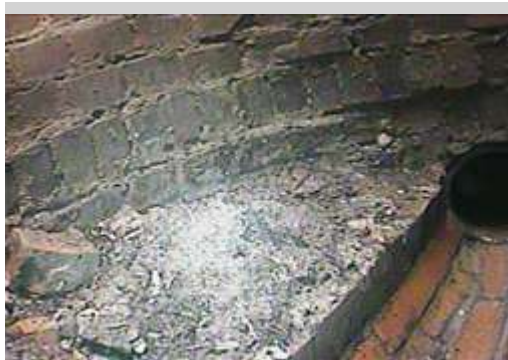
Defect

Bench ☒ Exists Material: **Brick** ☐ Parged ☒ **Debris** (not Condition related)

Surcharge ☒ **Evidence Of Surcharge** Depth: **1** (ft.) ☐ Active Surcharge Present

Evidence of surcharge - Bench debris.

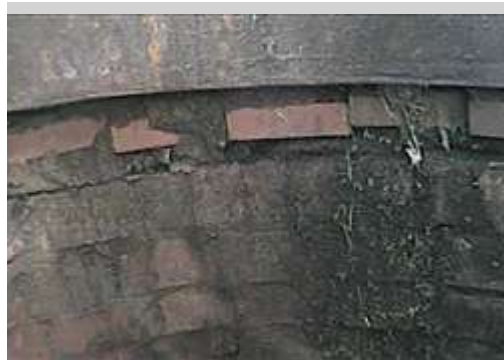
Defect

Condition: ☐ Sound ☐ Cracked ☐ Root Intrusion ☐ Loose Brick ☒ **Deteriorated**

Infiltration: ☐ None ☐ Joint ☐ Cracks ☒ **Mortar** ☐ Roots ☒ **Wall**

Barrel deterioration and infiltration.

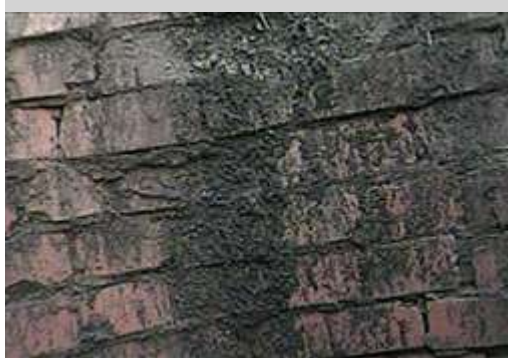
Defect

Frame Offset: **0** (in.) Condition: ☐ Sound ☐ Cracked ☒ **Leaks**

Condition: ☐ Sound ☐ Cracked ☒ **Root Intrusion** ☒ **Loose Brick** ☒ **Deteriorated**

Infiltration: ☐ None ☒ **Joint** ☐ Cracks ☒ **Mortar** ☒ **Roots** ☐ Wall

Frame leaks. Adjustment deterioration, loose brick, root intrusion and infiltration.

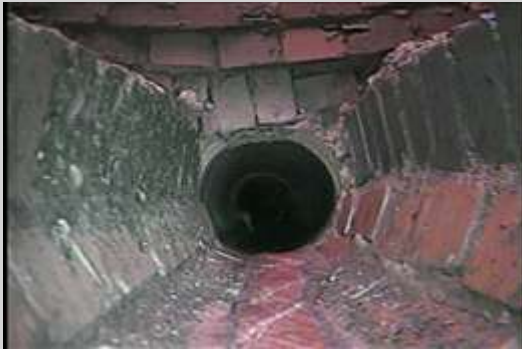
8 in. Circular Gravity Sewer Pipe Out @ 12 O'Clock

Barrel deterioration and infiltration.

Infiltration: **Evidence** Pipe Seal Cond: **Cracked**

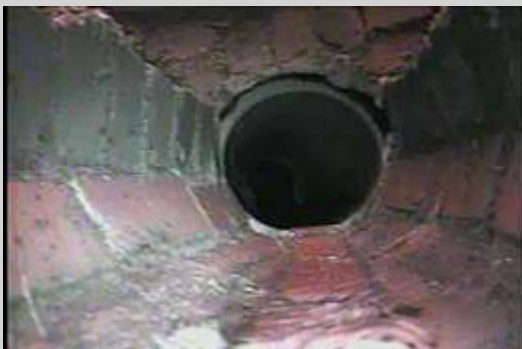
8 in. Circular Gravity Sewer Pipe In @ 6 O'Clock

Infiltration: **Evidence** Pipe Seal Cond: **Unknown**
